Clump Point Boat Ramp: Marine Ecology, Water Quality & Sediment Sampling Report

Reference: B22205_Report - Marine Ecology, Water Quality & Sediment Sampling.docx

Date: August 2016

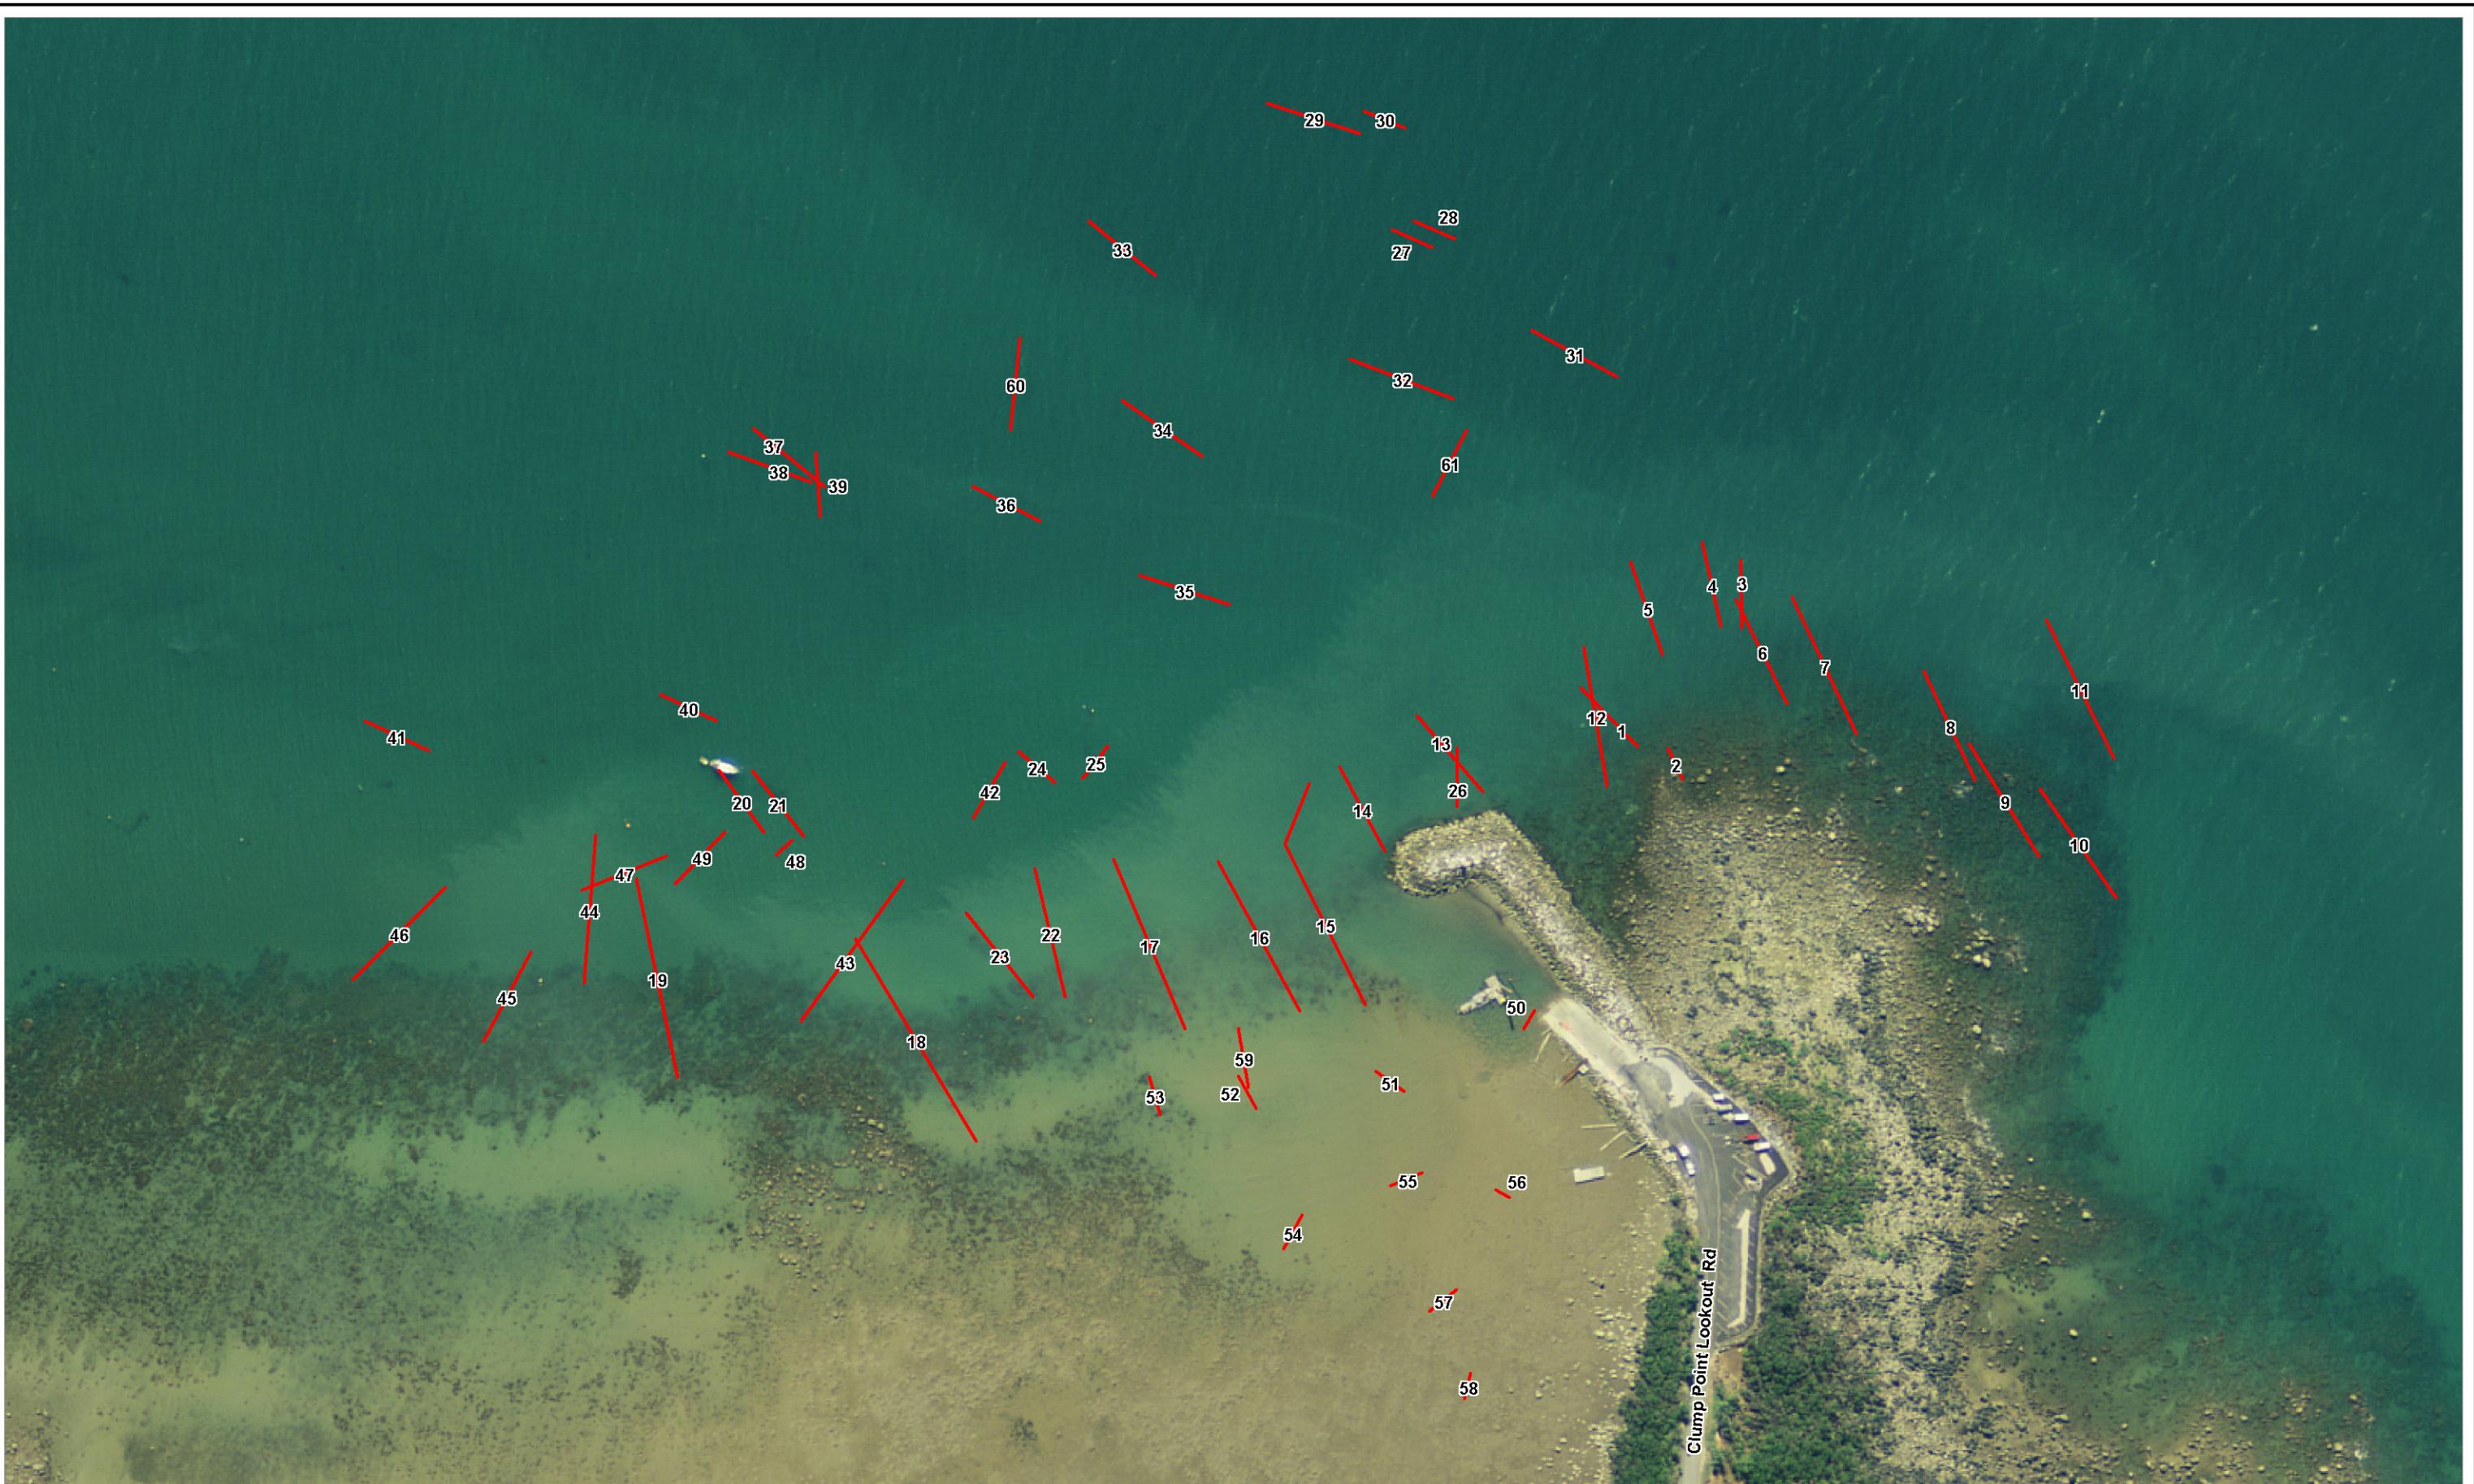
Title:
Location of Sampling Sites

Seabed habitats and benthic communities were assessed using an underwater video camera during 23-24 July 2017. The sites selected for surveys encompassed the range of habitats identified through bathymetry charts and habitat mapping from Roder *et al.* (1998). The locations of these sites are shown in Figure 2-1. Differential GPS was used on the survey vessel for position fixing and navigation to each sampling location.

At each transect, an underwater camera system was deployed by the passively drifting vessel for 4 minutes. Video footage was observed on a computer monitor in real-time and recorded to hard drive. A Van Veen grab was used to sample the seabed at selected sites to confirm sediment type and collect and identify any seagrass. Divers undertook inspections of the seafloor in each of the key habitat types, as well as large rock boulders (bommies).

Figure 2-1 Location of sampling sites

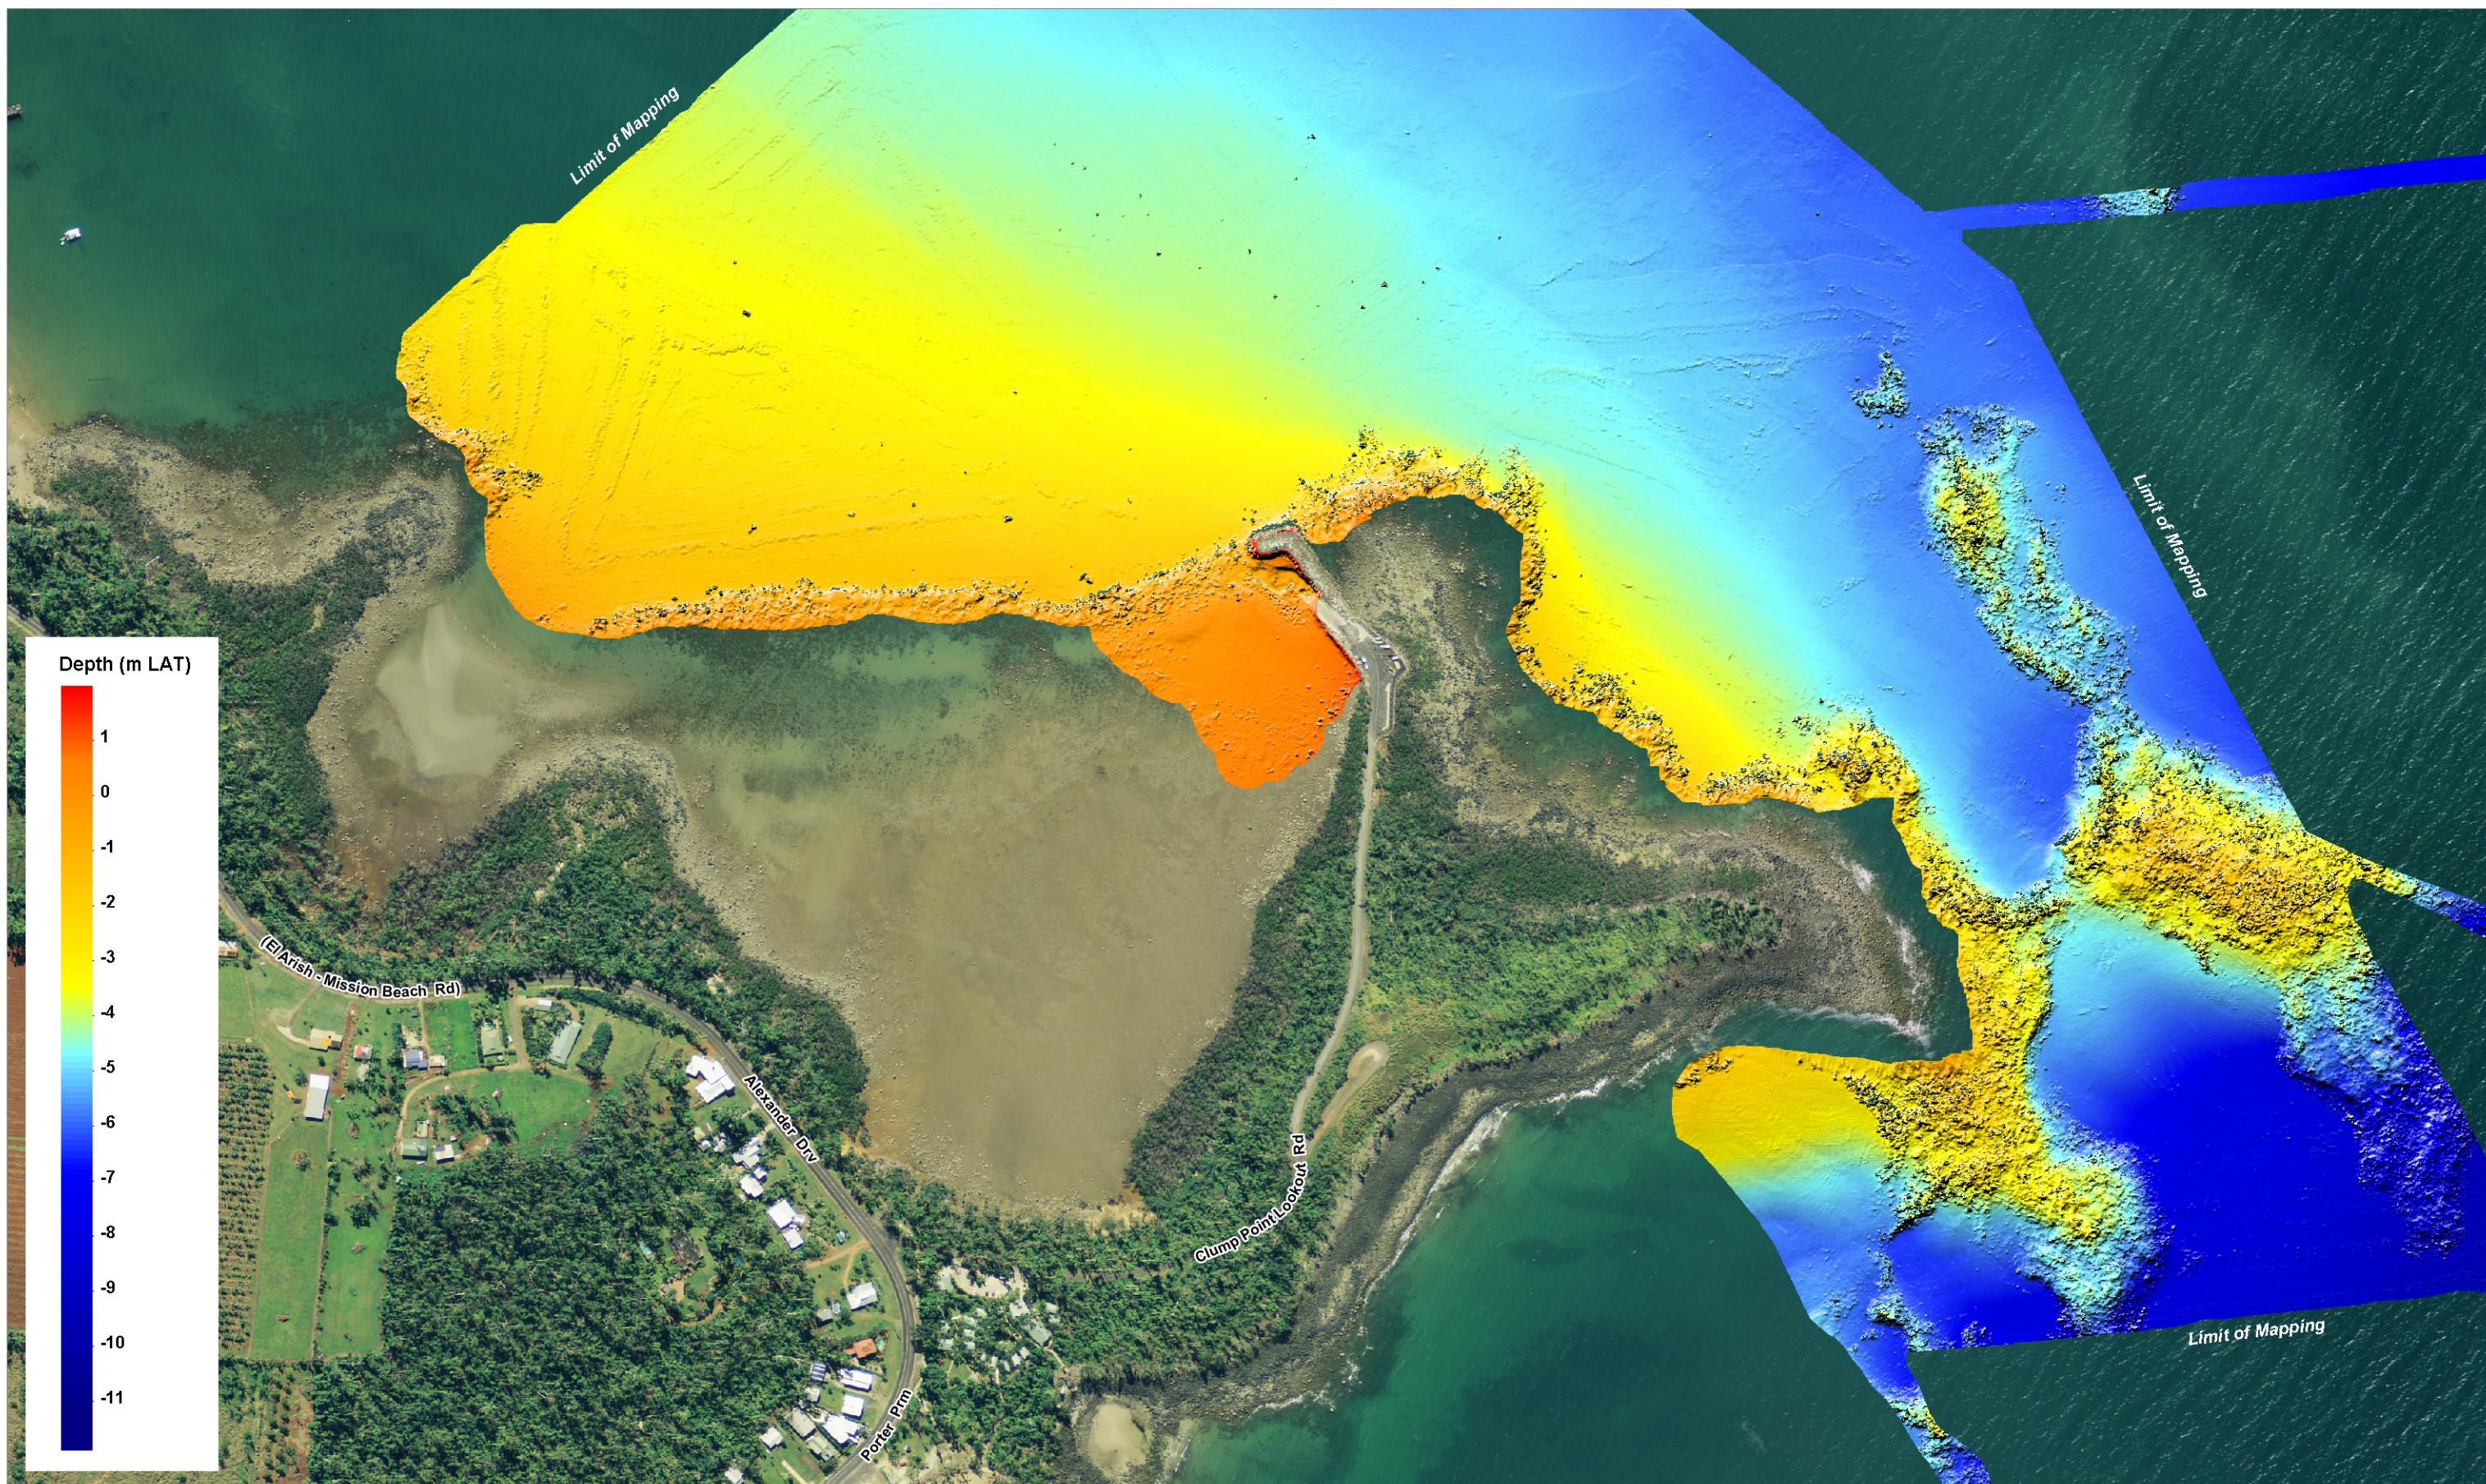
Figure
3-1 Rev:
A

Water depth is a key control on physical and biological processes that together affect the character of benthic habitats and communities. Figure 3-1 is a map of bathymetry in parts of the study area based on surveys carried out in July 2016 by Navigation Management Systems on behalf of DSD.

Boat Bay consists of a gently sloping tidal flat with (<1 m LAT). An area of slightly deeper water (-0.5 m LAT) occurs at the existing boat ramp. A band of complex terrain (boulder field – see Section B.3.2.2) extends along most of the northern perimeter of the bay to a depth of approximately -1.2 m LAT. The shoreline east of Clump Point boat ramp was fringed by a topographically complex intertidal rocky shore and subtidal reef system, which extends down to approximately -4.2 m LAT, but in places only extends to approximately -2 to -3 m LAT. Beyond the reef/boulder field the seabed was gently sloping and largely featureless, except for occasional reef patches, small scale features (bommies) and a wreck located near the boulder field at the entrance to Boat Bay.

Title:
Bathymetry of the Study Area Based on Surveys Carried Out for DSD in July 2016 (DSD unpublished data)

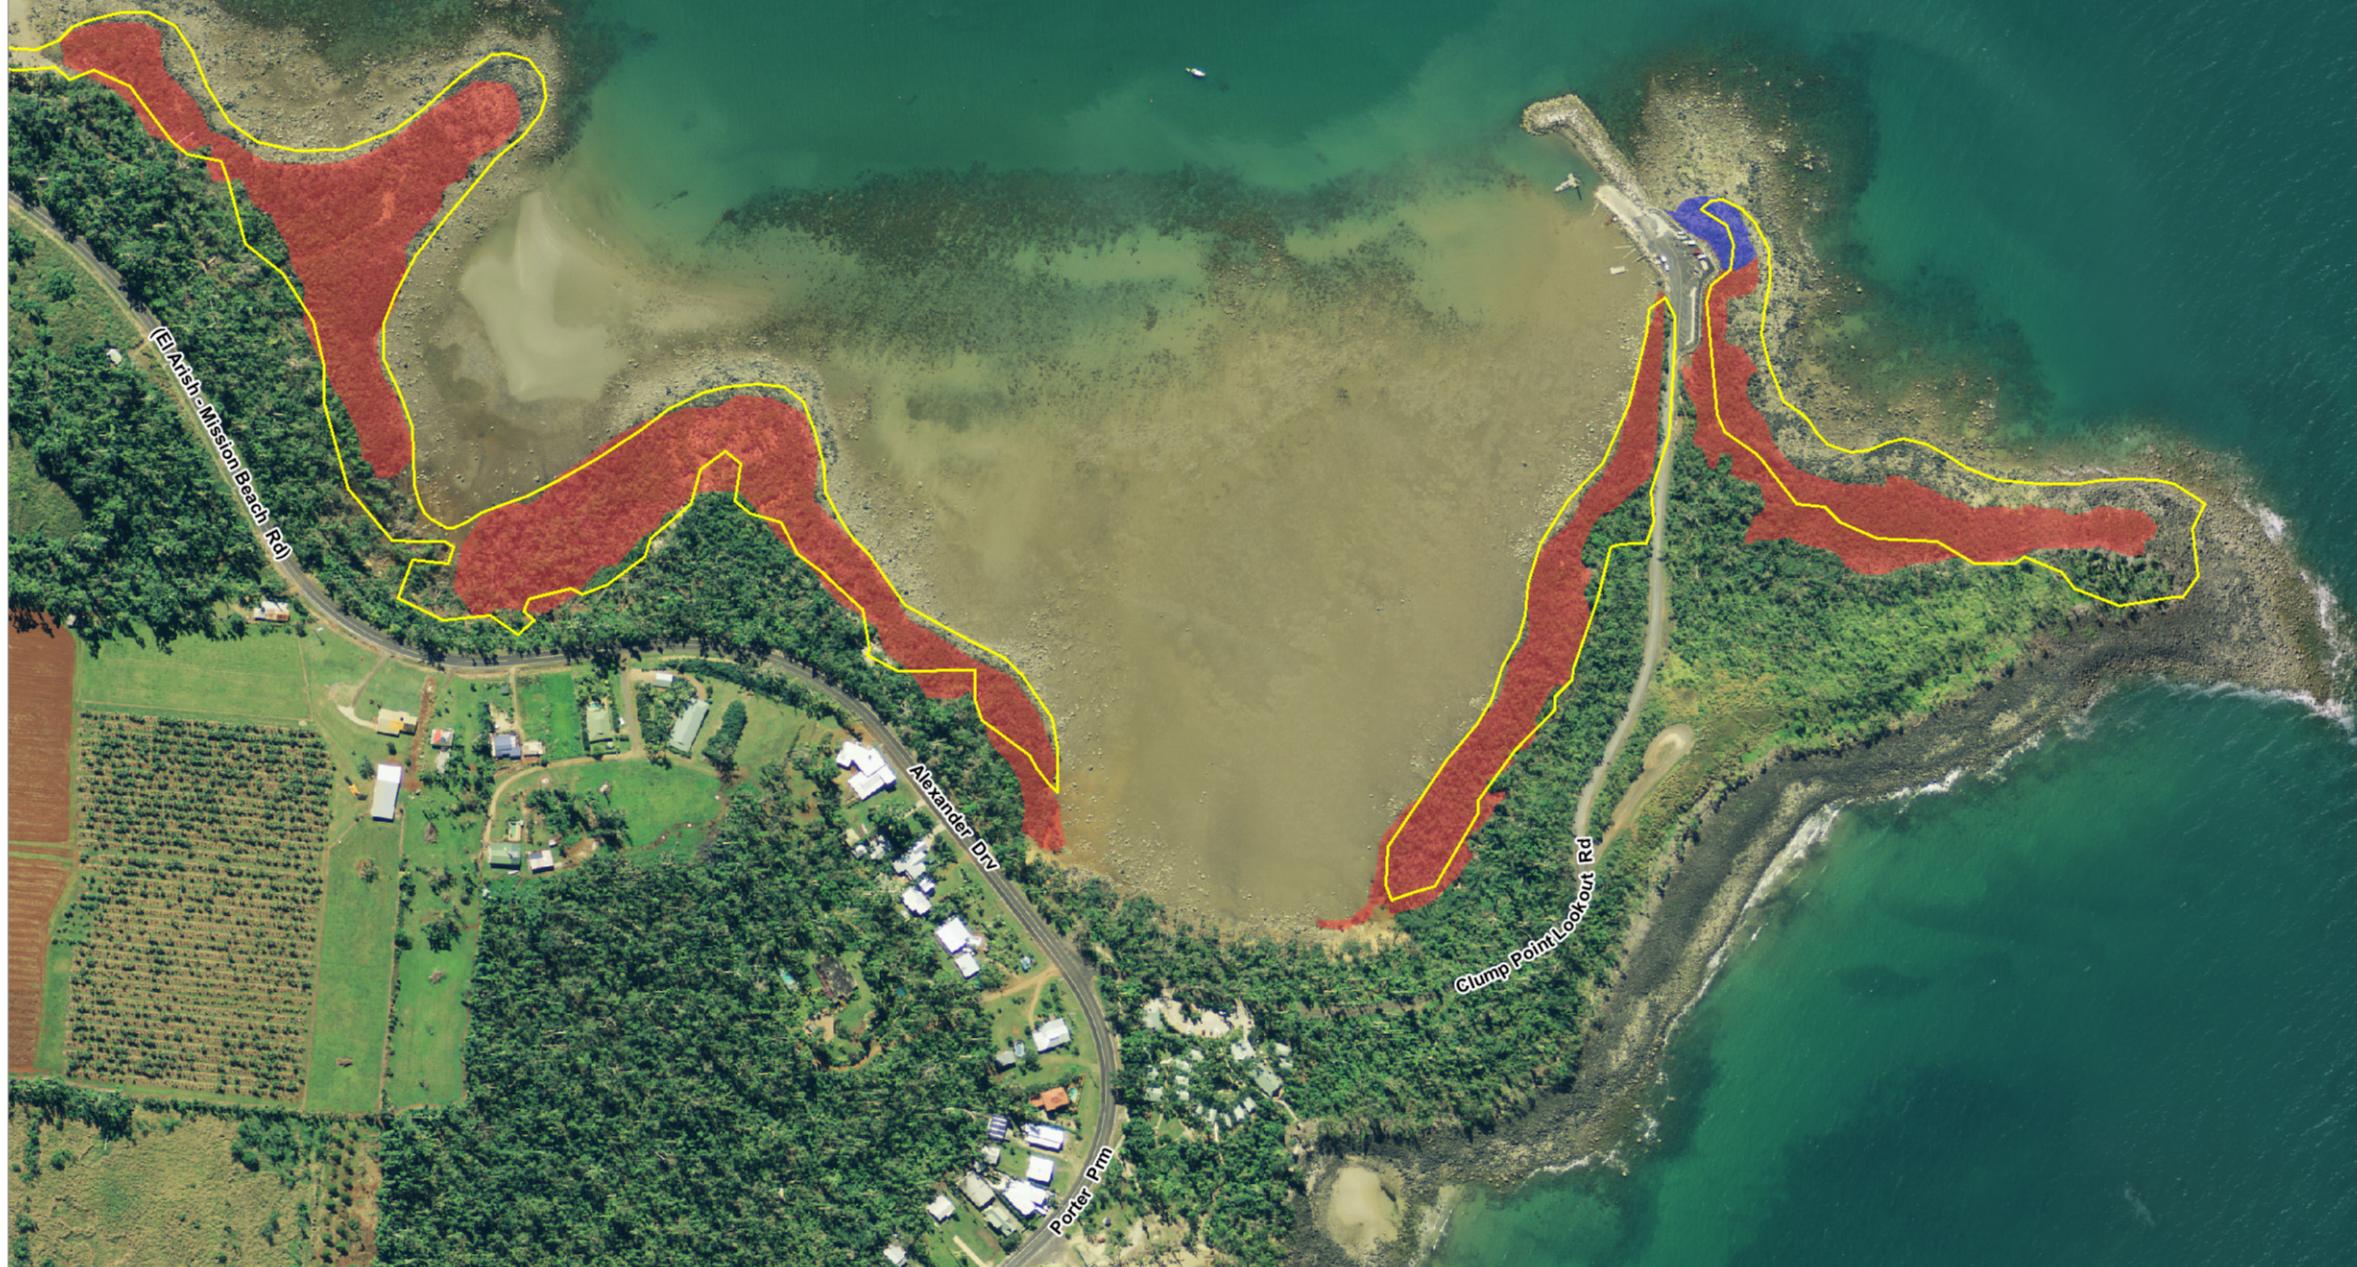
Mangrove communities in the study area are mapped as Regional Ecosystem (RE) 7.1.1 (Least Concern) which is described as mangrove closed scrub to open forest of sheltered coastlines, estuaries, and deep swales between dunes, on fine anaerobic silts, inundated with saline water at high tide (Figure 3-2).

Based on current RE mapping (V9.0), mangrove forest covered an area of 9 ha within the study area. Figure 3-2 also shows mangrove extent and type mapped at the local-scale based on interpretation of 2016 aerial imagery and field observations. Approximately 0.15 ha of *Avicennia marina* mangroves and 7.2 ha of *Rhizophora* spp. mangroves were mapped in the study area.

The western and eastern shorelines of Boat Bay and the eastern shoreline of Clump Point had a narrow (averaging 20-60 m wide) fringe of mangrove forest occurring landward of sand/mud shoals and boulder fields (Figure 3-3). The mangrove forest on the western shoreline of Boat Bay was numerically dominated by *Rhizophora stylosa*, *Avicennia marina* was sub-dominant, and *Aegiceras corniculatum* formed an under-storey canopy in places. *Rhizophora apiculata* was more abundant in the mangrove forest on the eastern shoreline of Boat Bay, and the landward margin of this forest also contained *Osbornia octodonta*, *Ceriops tagal* and *Aegiceras corniculatum*. Only isolated mangroves, dominated by *A. marina*, occurred directly adjacent to the existing boat ramp (refer Figure 3-2). No saltmarsh or saltpan have been recorded in the study area.

Title:
Mangrove Vegetation

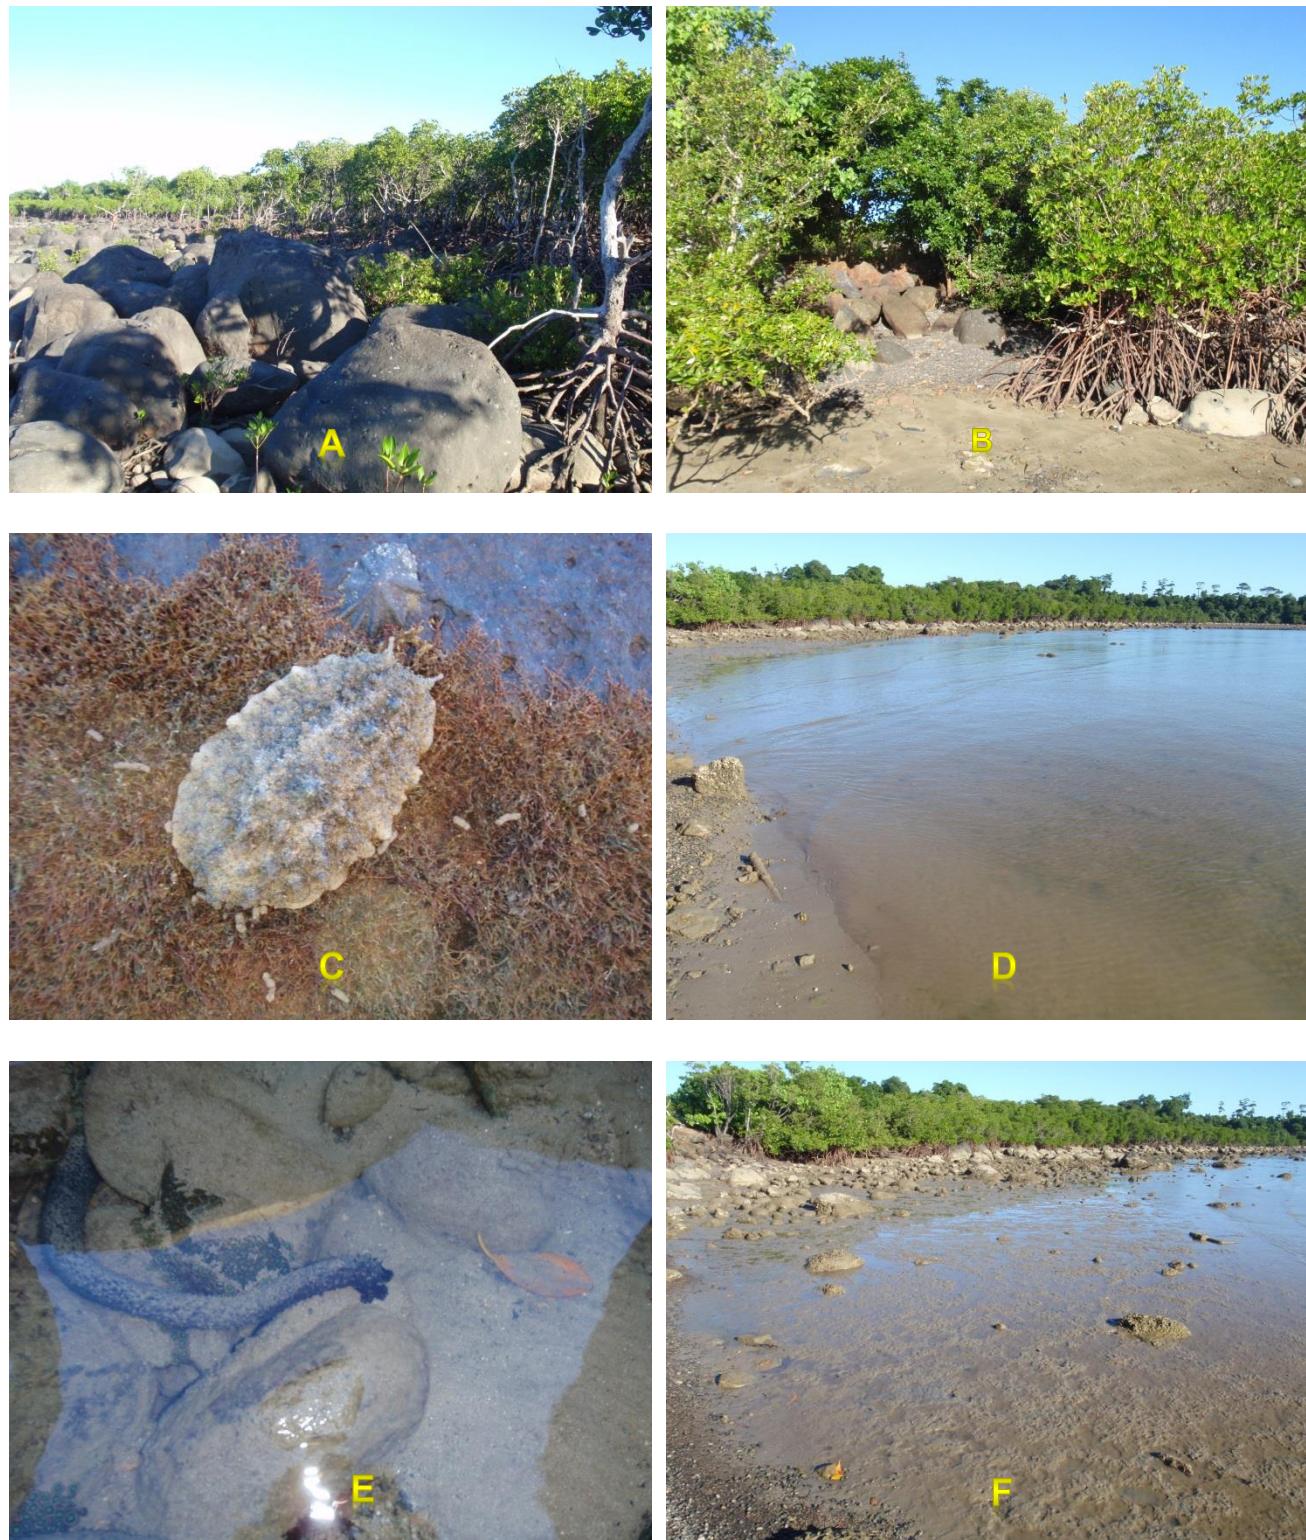
A Rhizophora species and boulder field; **B** Rhizophora species and sedimentary habitat; **C** = nudibranch in boulder habitat; **D** sand shoals; **E** rock pool with *Holothuria leucospilota*; **F** Heavily worked intertidal sand/mud shoals

Figure 3-3 Photographs of mangroves and foreshore habitats in the study area

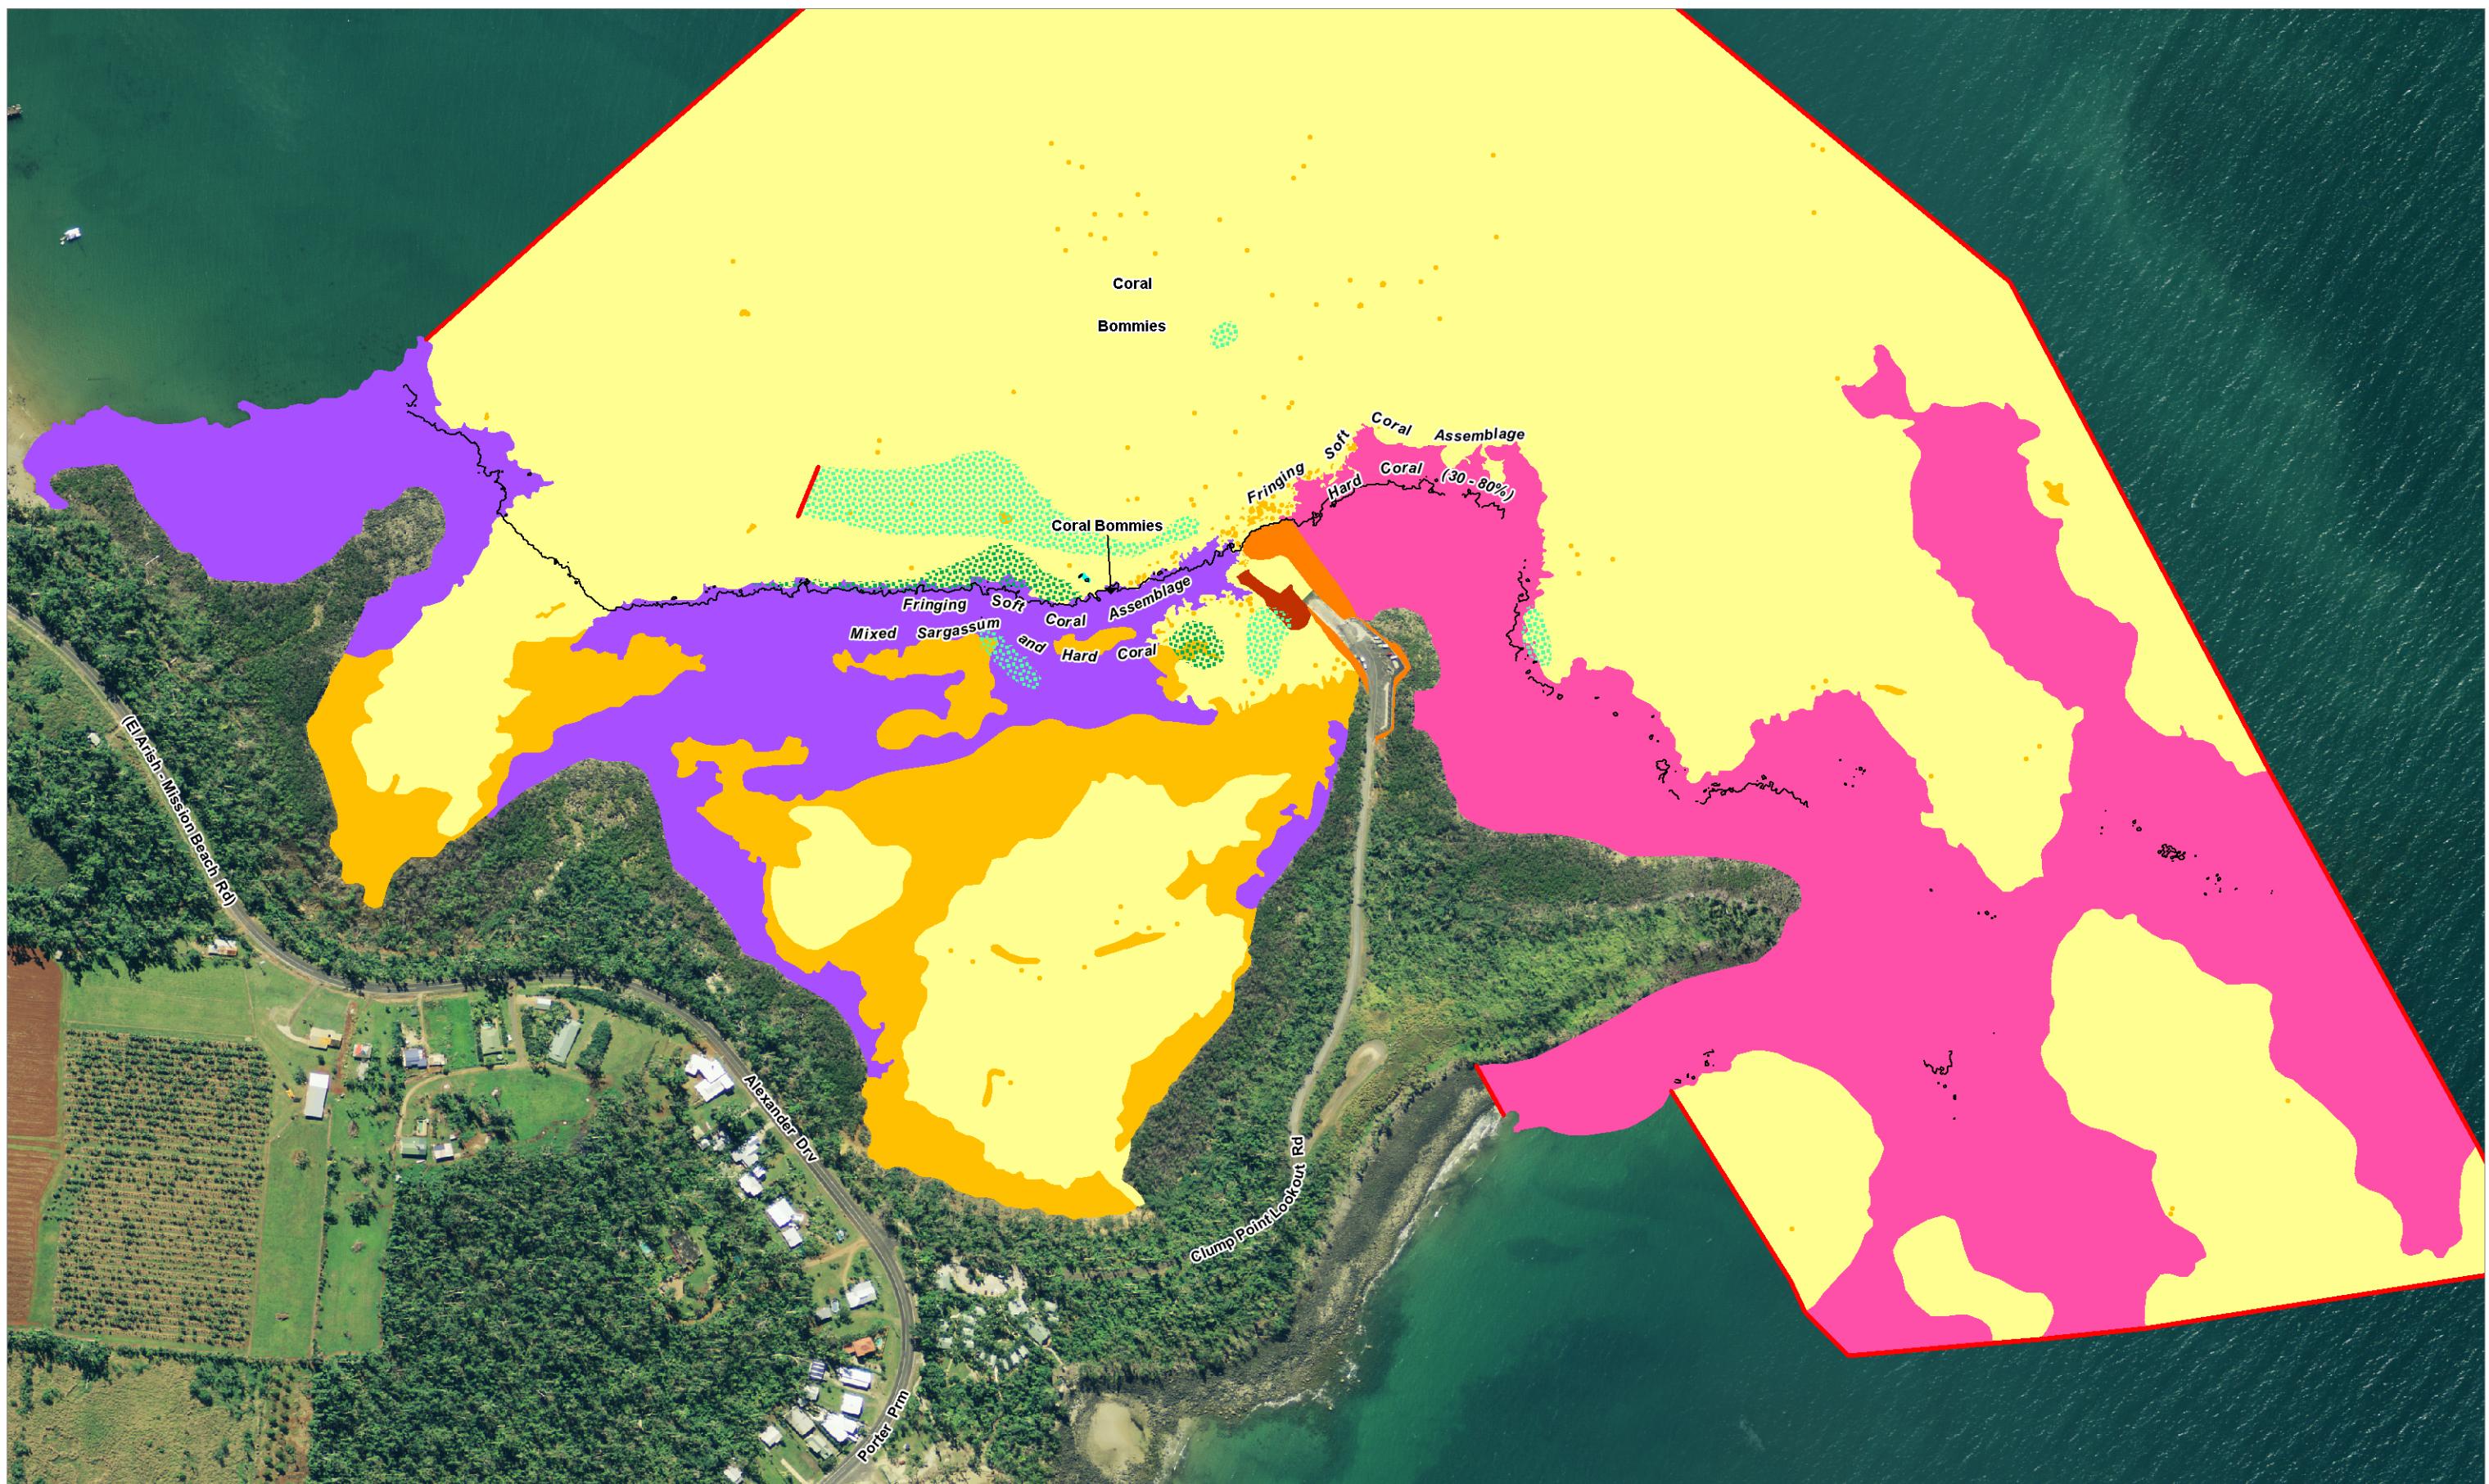
Surveys conducted in July 2016 recorded one seagrass species: *Halodule uninervis*. Two mono-specific meadows were recorded (Figure 3-4):

- Meadow 1 was located on the seaward edge of the basalt boulder field on the northern edge of Boat Bay, at approximately -1 to -1.7 m below LAT. This meadow had a total area of 0.34 ha and had sparse (<1%) cover.
- Meadow 2 was located immediately landward of the edge of the basalt boulder field on the northern edge of Boat Bay, at approximately -0.2 m below LAT. This meadow had a total area of 0.12 ha and had sparse (<1%) cover.

Figure 3-4 is a map of the distribution of rocky shores, rock walls and reef environments in the study area. Figure 3-13 is a map of benthic habitat features immediately seaward of the existing rock wall, which further sub-divides reef and rocky habitats into sub-classes. Photographs of representative taxa and features are shown in Figure 3-5, Figure 3-6 and Figure 3-7. The following reef/rocky shore habitat types occur in the study area.

In time, it is expected that seagrass will continue to recover, potentially occupying similar areas as observed by Roder *et al.* (1998) as shown in Figure 3-4.

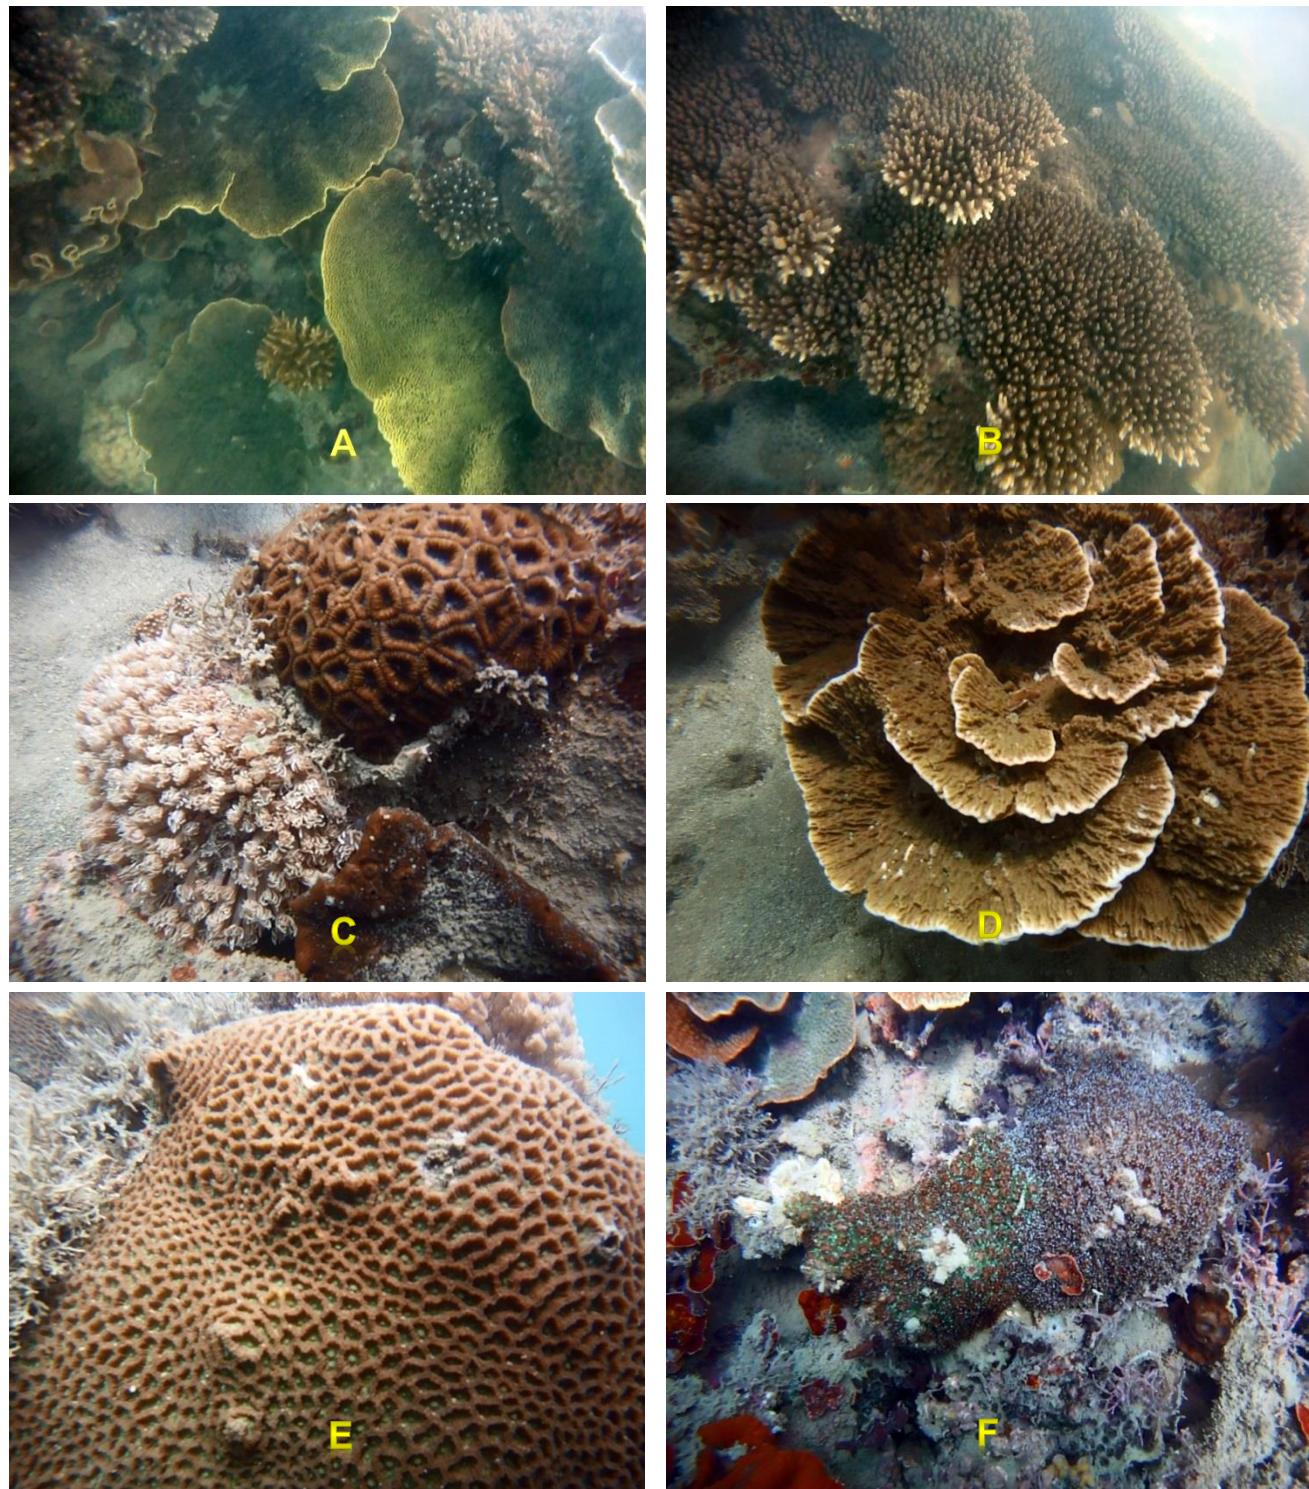
A Mixed assemblage of plating *Montipora* and *Acropora* hard corals; **B** plating *Acropora*; **C** *Alveopora* and *Favia* ; **D** *Merulina*; **E** *Favia*; **F** *Galaxea* and *Turbinaria* hard corals with sponges and coralline algae

Figure 3-5 Photographs of subtidal reef features (hard corals) on Clump Point reef

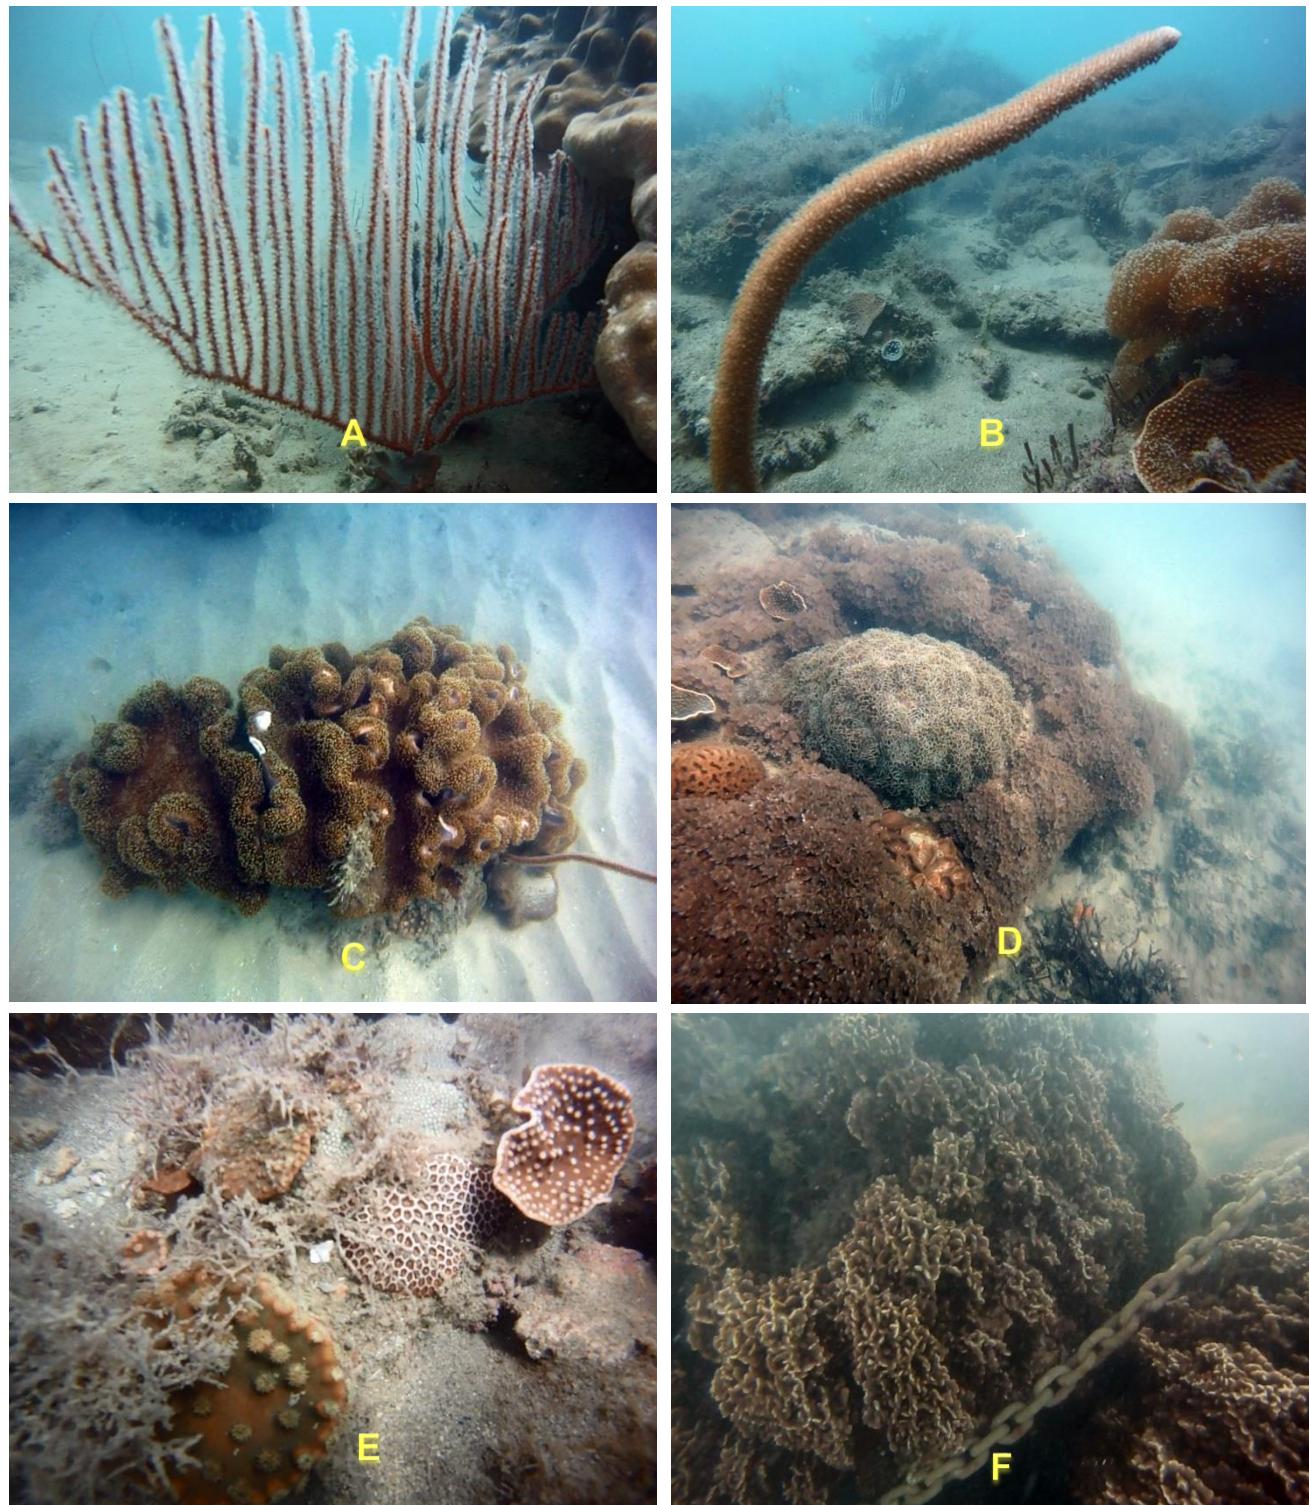
A Gorgonian (*Ctenocella*); **B** Sea whip (*Juncella*) and soft coral (*Sarcophyton*) ; **C** *Sarcophyton*; **D** Soft coral assemblage on the seaward margin of the Boat Bay boulder habitat; **E** Mixed benthic assemblage; **F** anchor chain on coral head at Boat Bay boulder field

Figure 3-6 Photographs of subtidal features in Boat Bay boulder fields and Clump Point reef
