Clump Point Boat Ramp: Marine Ecology, Water Quality & Sediment Sampling Report

Reference: B22205_Report - Marine Ecology, Water Quality & Sediment Sampling.docx

Date: August 2016

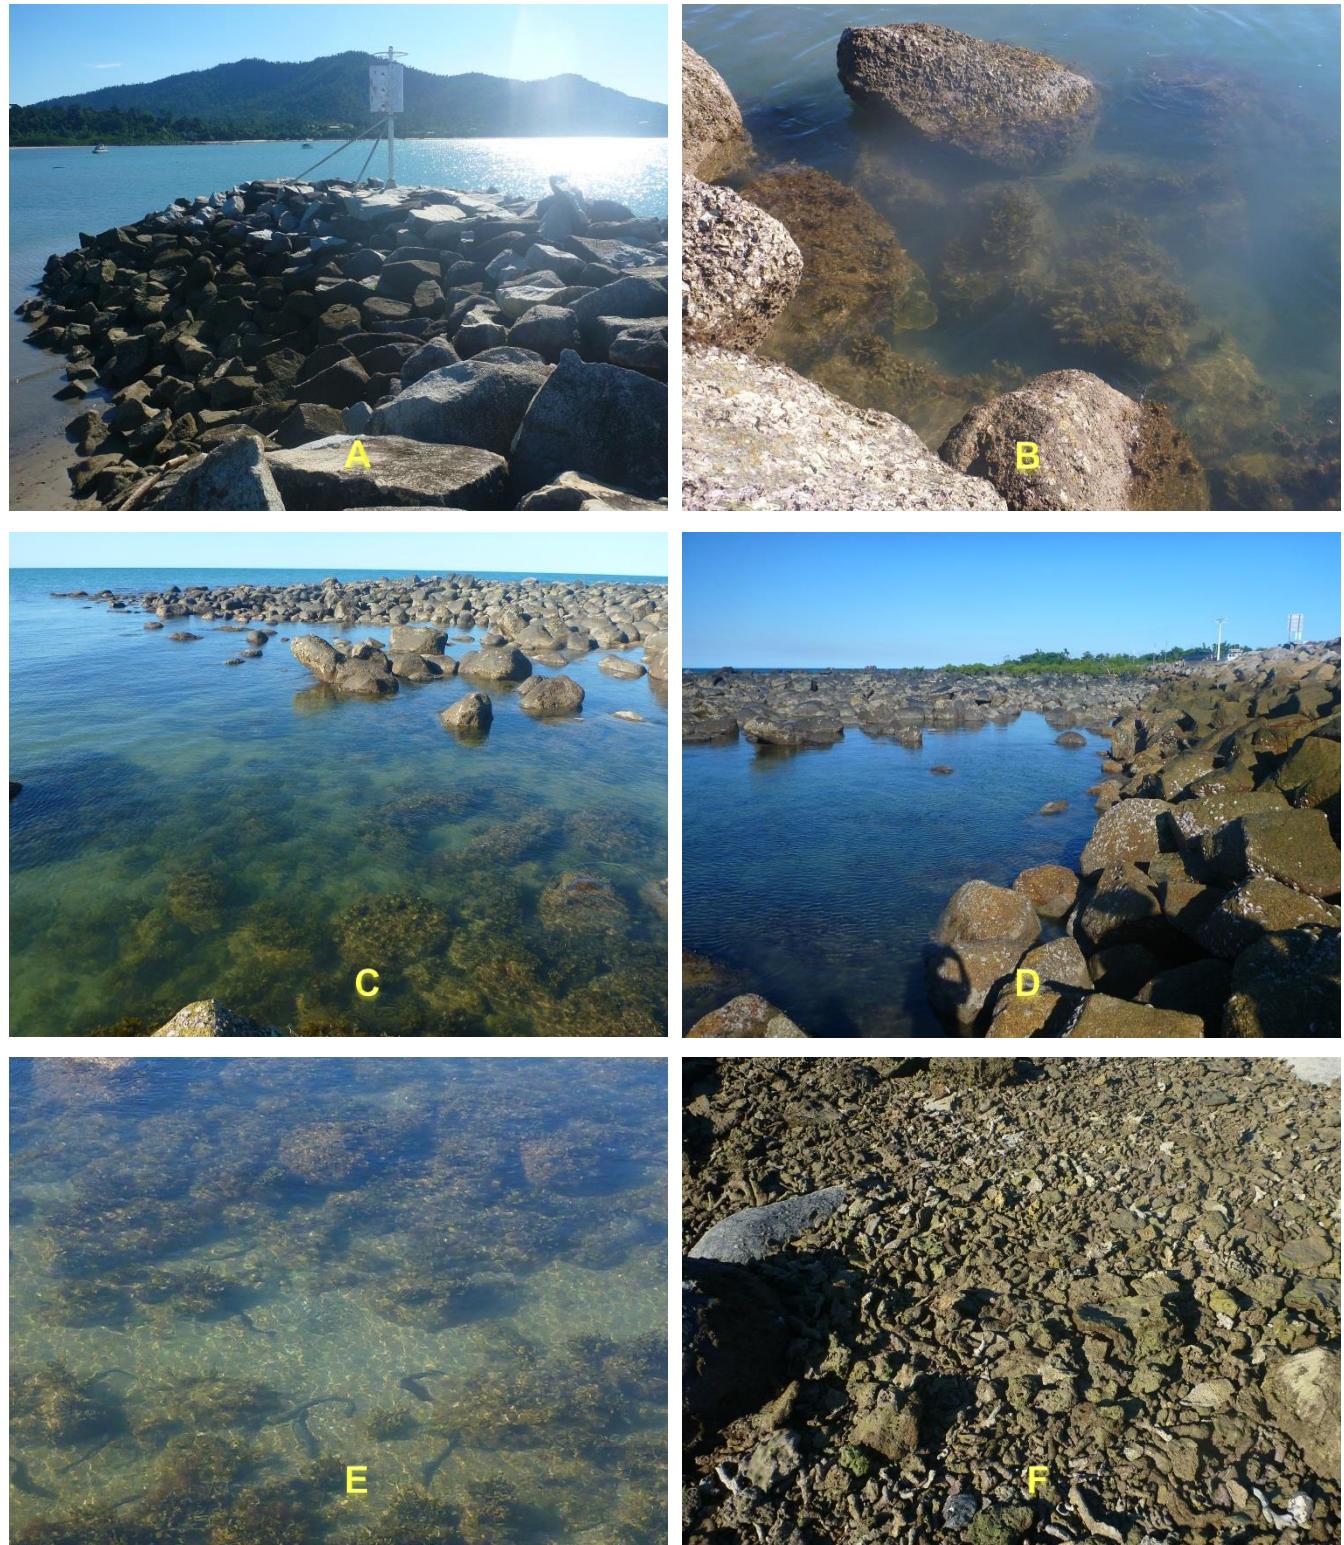
A Rock wall in Boat Bay; **B** Intertidal zone of the rock wall within Boat Bay ; **C and D** Intertidal boulder field and rock pools on the east side of rock wall adjacent to car park; **E** Rock pool adjacent to car park; **F** Coral rubble on reef flat

Figure 3-7 Intertidal habitats adjacent to the existing rock wall and car park

An intertidal fringe of isolated basaltic boulders and cobble on soft sediment occurred along the shoreline of Boat Bay and Clump Point (Figure 3-7). The boulder field to the east of Clump Point consisted of sand and coral rubble amongst the boulders. West of Clump Point the sediment between the boulder field was a mixture of mud, coral rubble and sand.

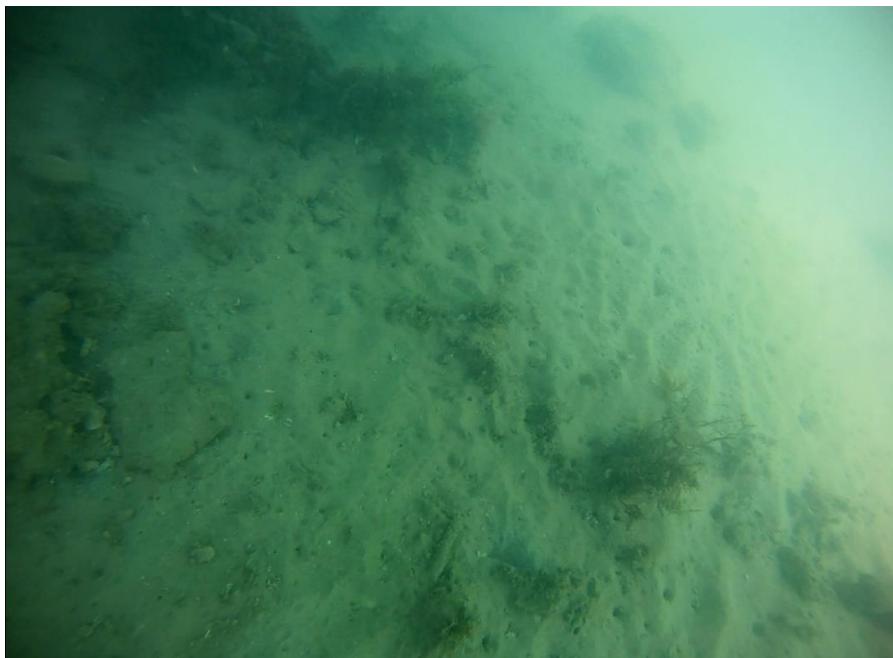
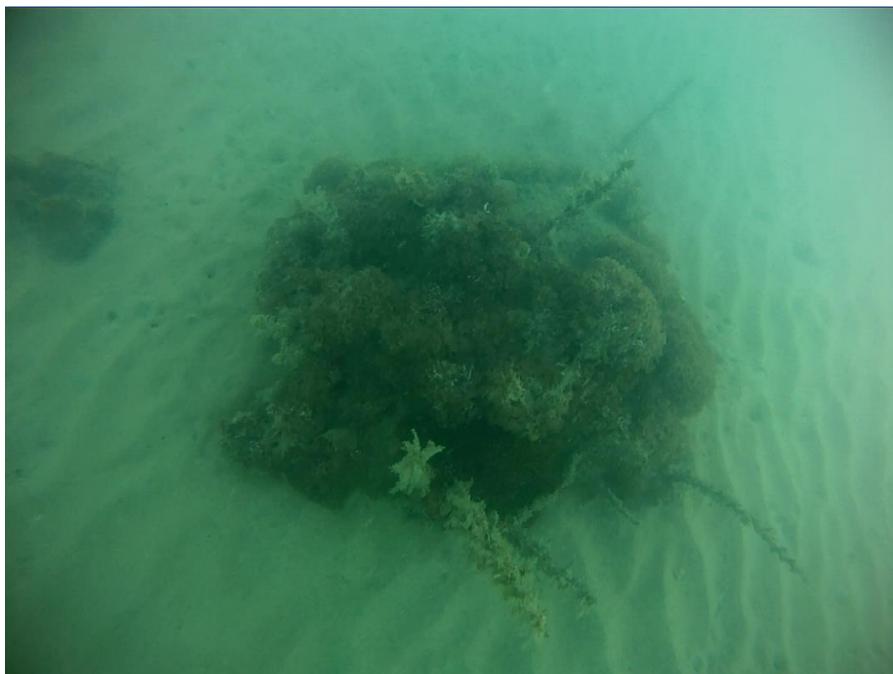
Immediately adjacent to break-water: sand, rubble and algae

Transect continues mostly over sand, occasional boulders with soft coral and hydroids present ~15m from break-water

Figure 3-8 Soft sediment and rubble habitat on Transect 14 on the northern margin of the rock wall

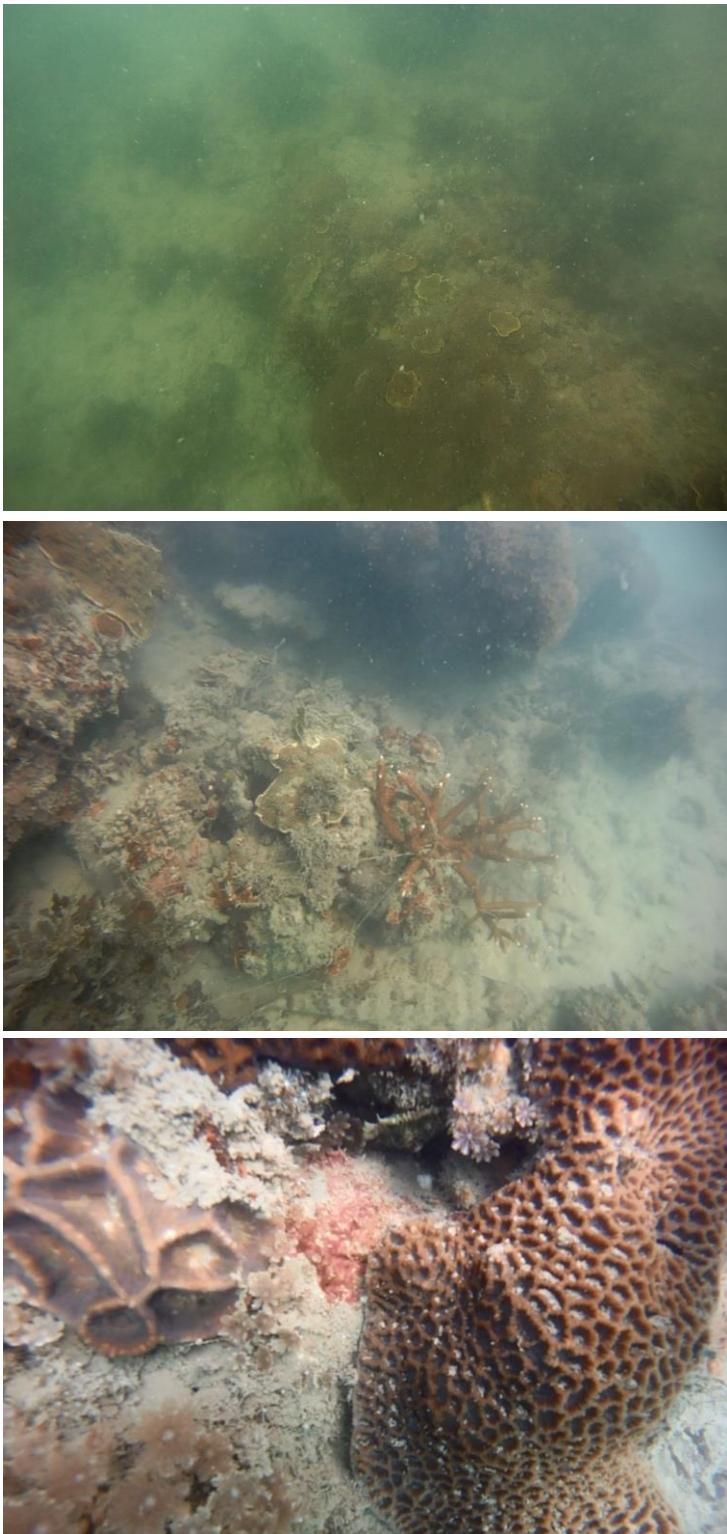
Base of the break-water:
Eflatournia soft coral and
Turbinaria and *Acropora* hard
coral, with rubble and algae

Bommies covered in *Eflatournia* soft coral and *Faviidae* hard coral also present immediately offshore of break-water (within ~10 m)

Figure 3-9 Boulders, rubble and soft habitat adjacent to the northern margin of the rock wall (Transect 13)

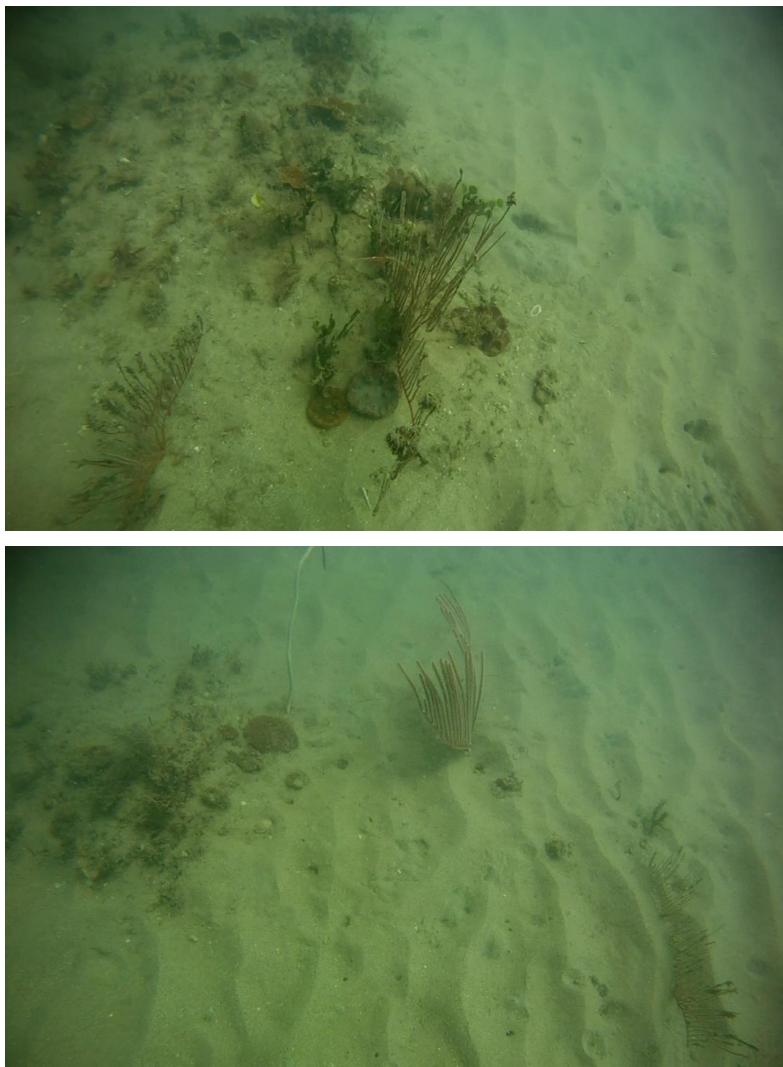
Mostly sandy substrates >10-15 m from break-water, with occasional clusters of soft coral, small faviids and macroalgae

Figure 3-10 Boulders, rubble and soft habitat >20 m from the northern margin of the rock wall (Transect 13 cont'd)

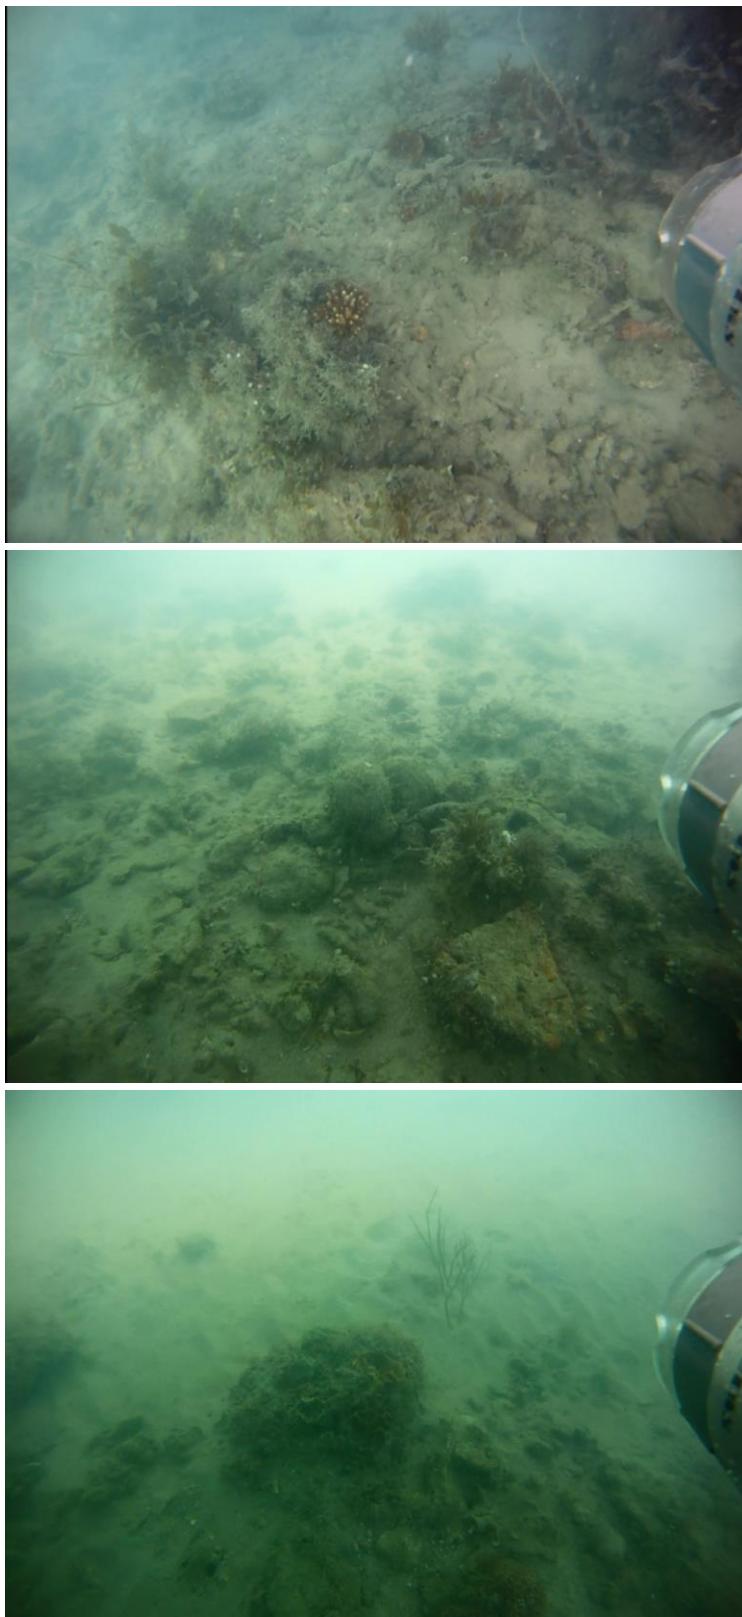
Immediately adjacent to rock wall:
mostly rubble at base of wall with
some small hard corals (1-5%)
and mostly algae

Mostly rubble within 10 m of wall

At end of rubble, isolated boulders
with *Turbinaria* hard coral colony
and occasional soft coral

Figure 3-11 Boulders, rubble and soft habitat adjacent to the northern margin of the rock wall (Transect 26)

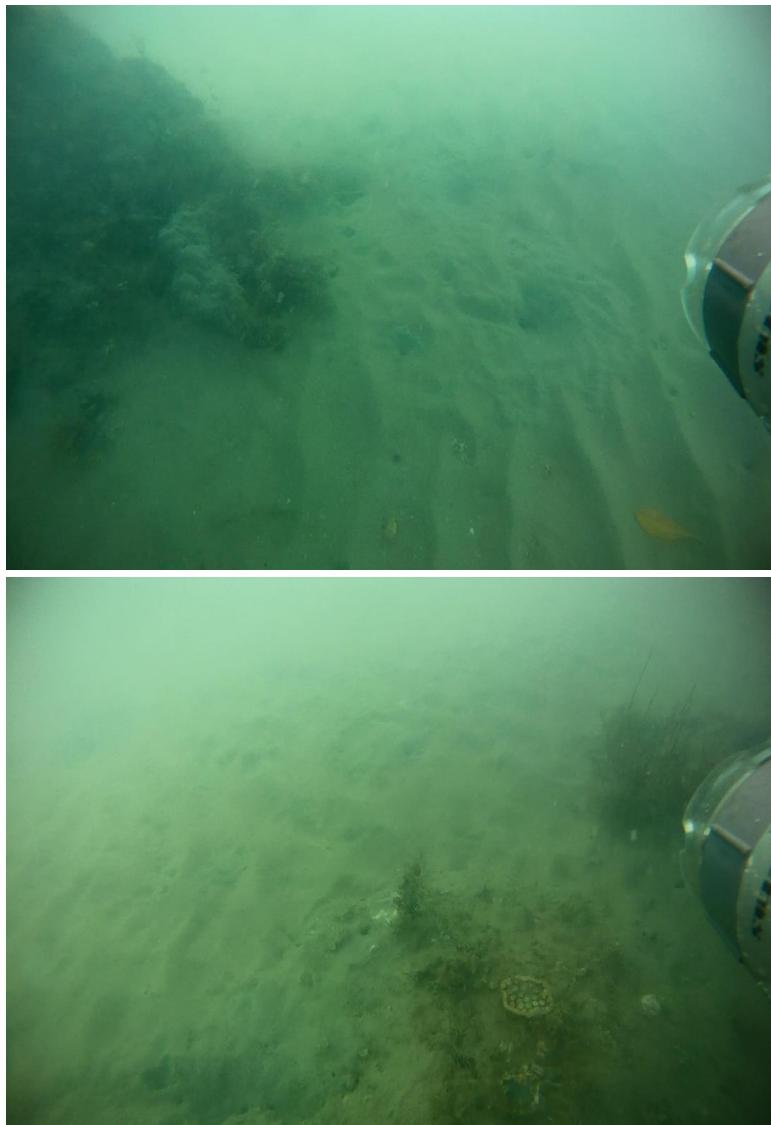
Transect continues through sand before passing one large living *Porites* coral ~20 m from break-water

Continues over sand , some low relief boulders with hard and soft corals

Figure 3-12 Boulders, rubble and soft habitat >20 m from the northern margin of the rock wall (Transect 26 cont'd)

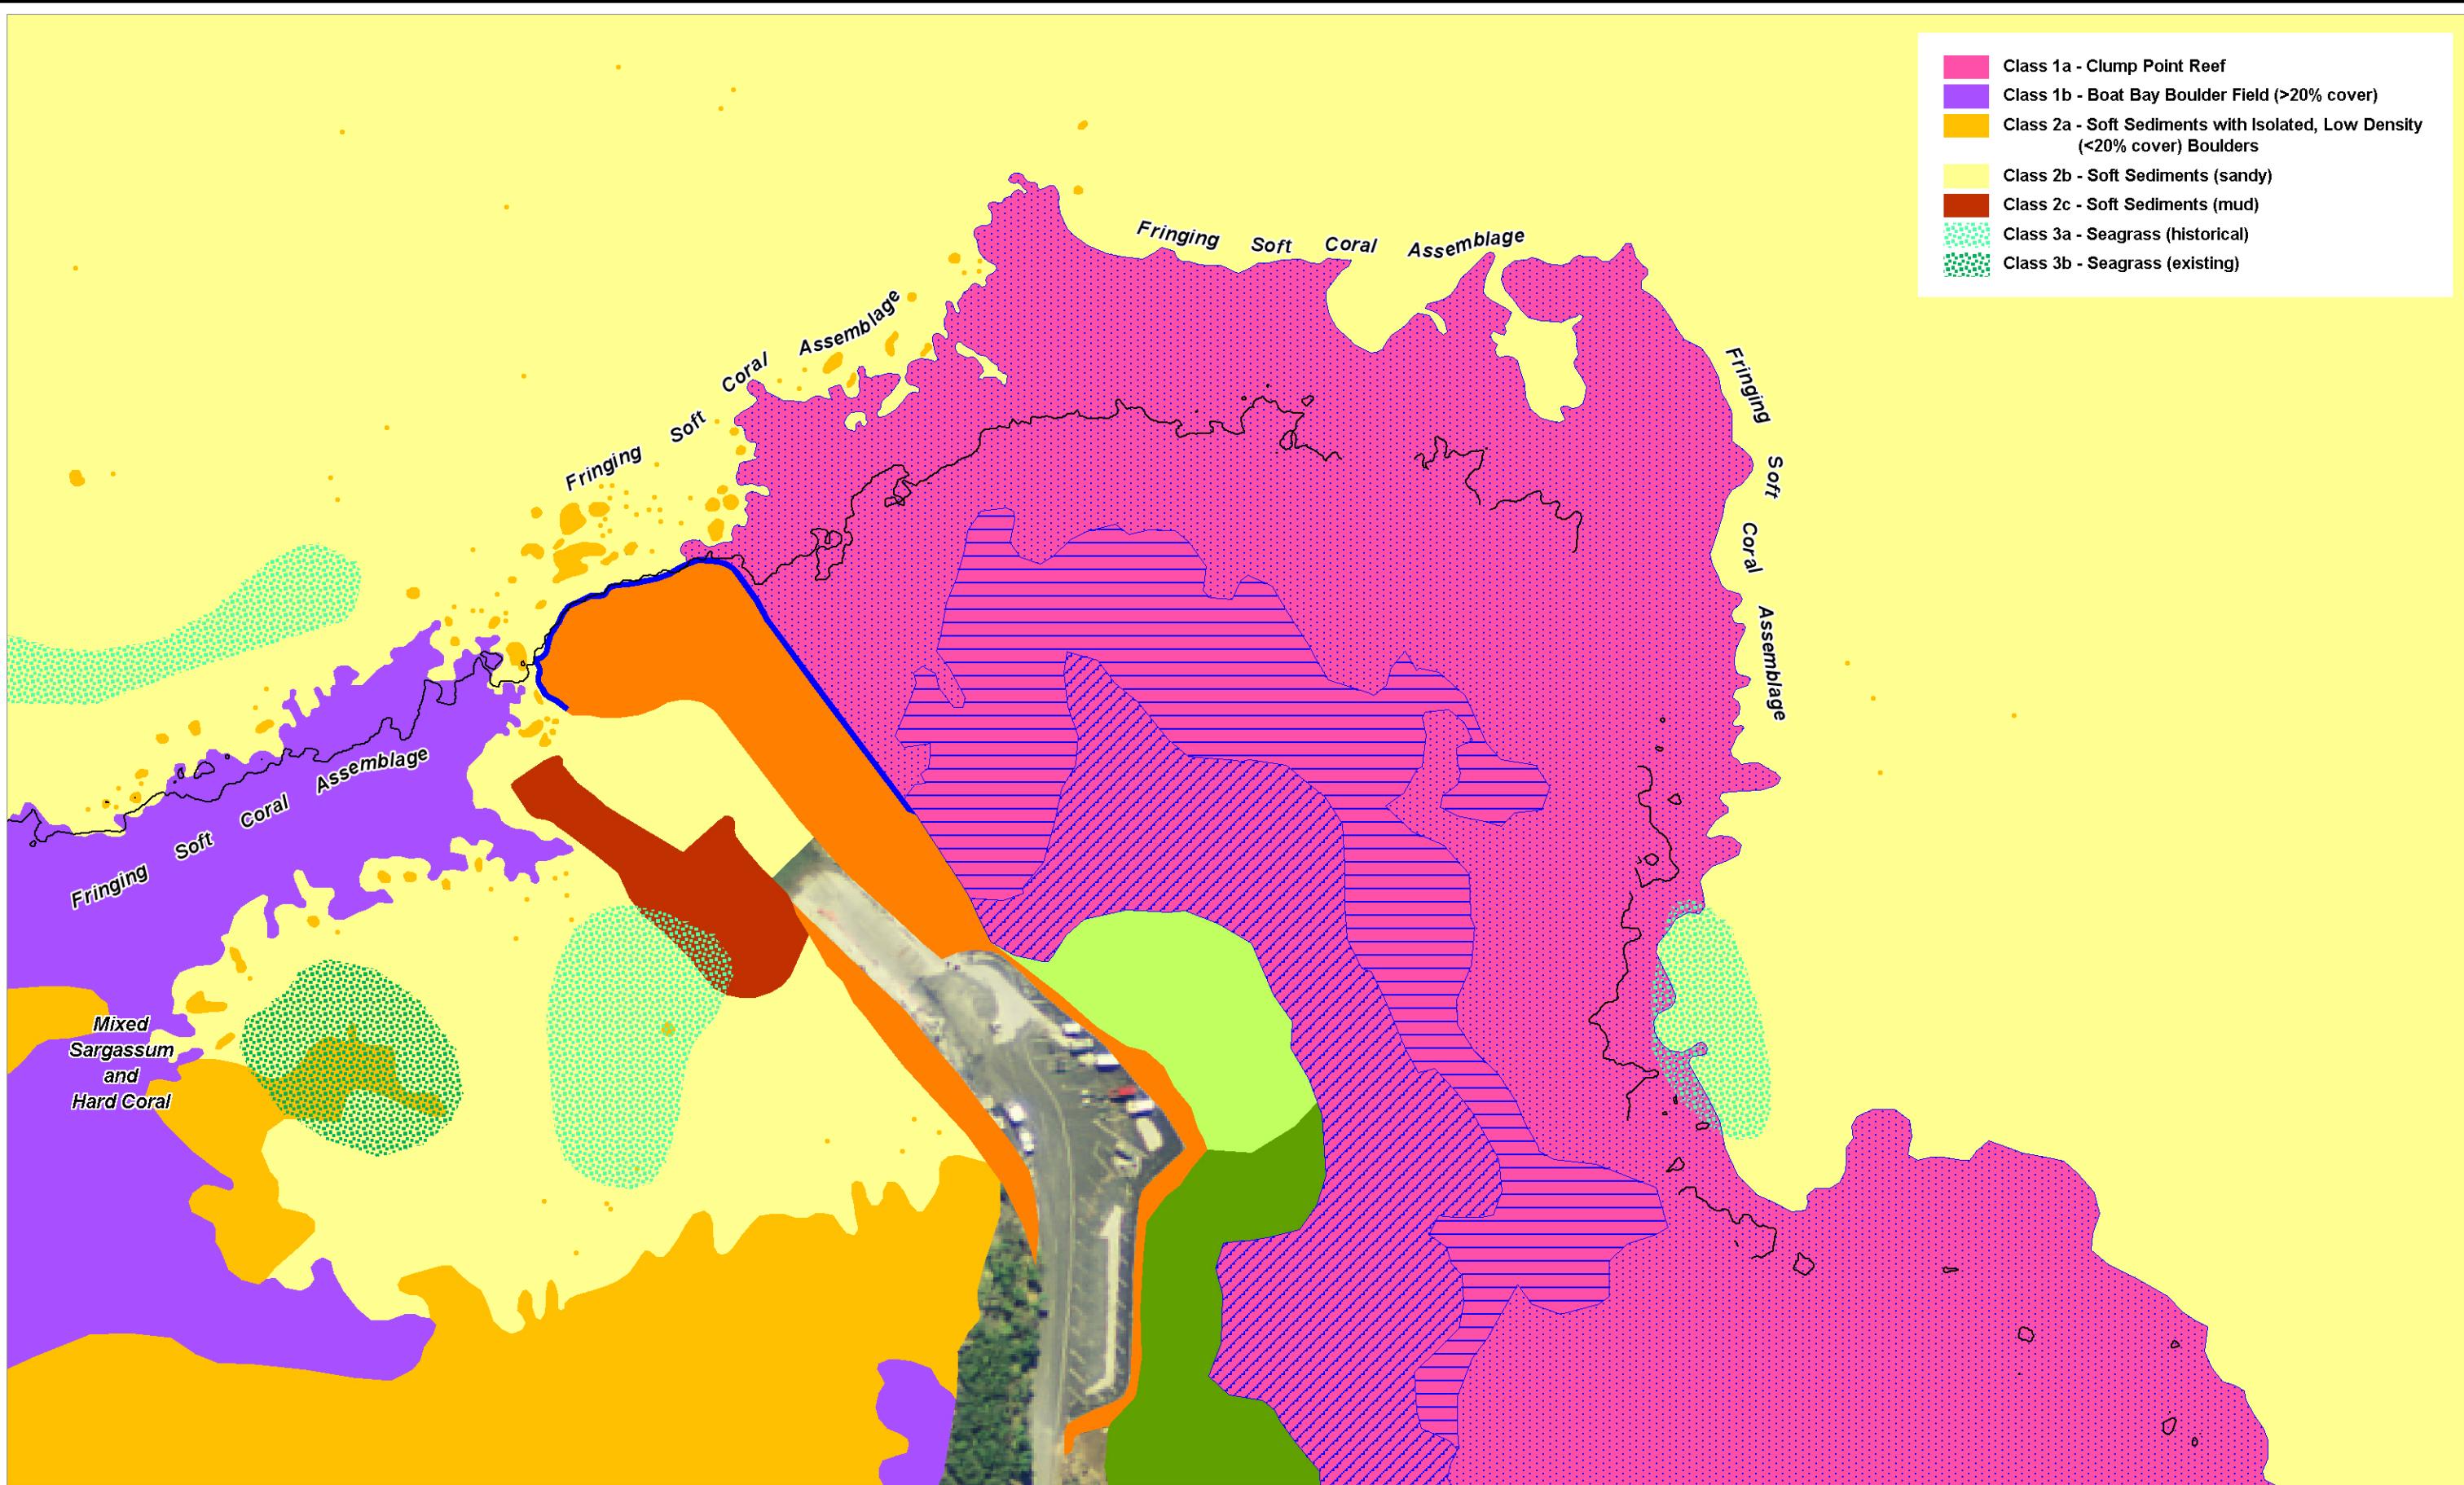
Figure 3-4 is a map of the distribution of rocky shores, rock walls and reef environments in the study area. Figure 3-13 is a map of benthic habitat features immediately seaward of the existing rock wall, which further sub-divides reef and rocky habitats into sub-classes. Photographs of representative taxa and features are shown in Figure 3-5, Figure 3-6 and Figure 3-7. The following reef/rocky shore habitat types occur in the study area.
